AFRL-RX-TY-TR-2010-0096

EVALUATION OF DETERGENT RUBBER REMOVAL SYSTEM UNDER EXPEDITIONARY CONDITIONS IN SUPPORT OF OPERATION UNIFIED RESPONSE

August 2010

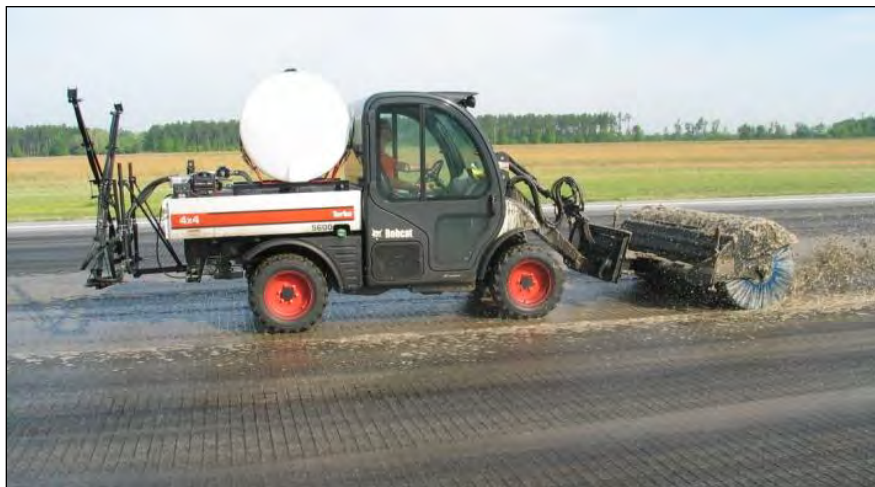
Figure 1. The Detergent Rubber Removal System in Operation at North Field

The basic system consists of a Bobcat Toolcat[®] with angle broom attachment, an agricultural sprayer system in the bed of the Toolcat[®], a water trailer and rubber removal detergents. The Bobcat Toolcat[®] was originally chosen for its agility and versatility in the field. It is a highly configurable platform that has the ability to accomplish a wide variety of tasks by utilizing multiple attachments. Figure 1 shows the detergent rubber removal system scrubbing the runway surface after application of the rubber removal detergent. The water spray bar uses high pressure water (at 40 psi) to push the cleaning residue off the pavement surface (Figure 2).

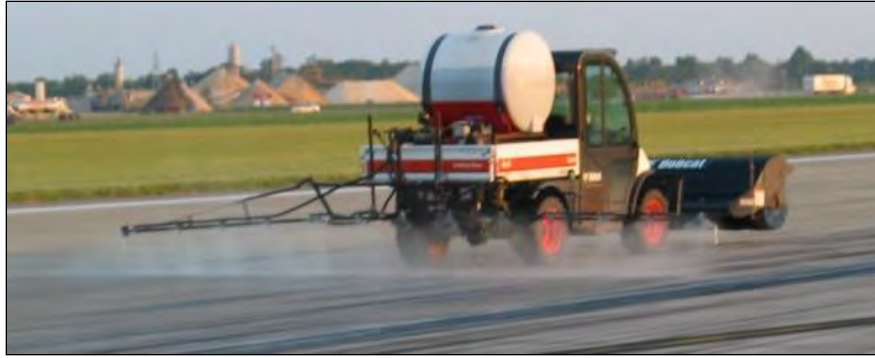
Figure 2. Water Spray Bar Folds Out to Push Rubber Residue Off the Pavement

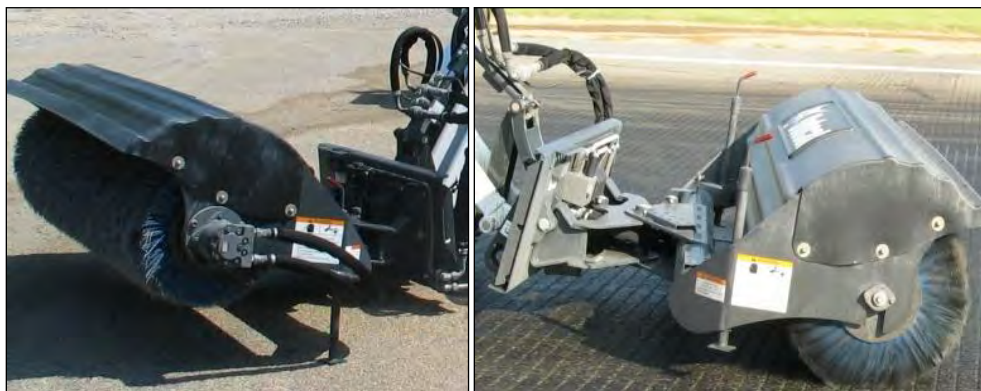
The broom attachment (Figure 3) is a standard Bobcat[®] accessory for the Toolcat[®]. AFRL modified the configuration of poly- and steel-bristle wafers to provide adequate scrubbing and water movement capabilities when used in conjunction with the rubber removal detergents. The Toolcat's 26-gal/min high-flow hydraulic system is well suited for this application.

Figure 3. The System Uses the Broom Attachment to Scum the Chemical

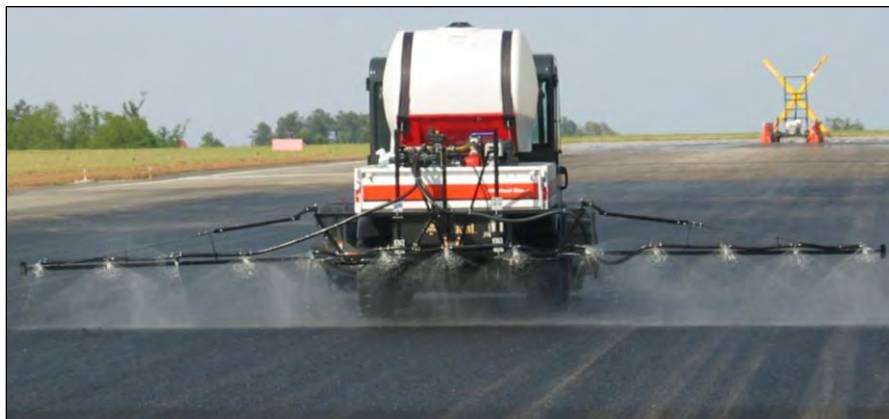
The AFRL-modified agricultural sprayer system (Figure 4) includes a 200-gal poly tank, gas-powered pump, and 21-ft wide folding sprayer boom (Figure 5). Initial testing started with a smaller tank and pump system that was inadequate for rubber removal requirements. The new system is capable of supplying 20 gal/min at a pressure of 40 psi. The 200-gal polyethylene horizontal storage tank can store sufficient rubber removal detergent to treat approximately 40,000 sq ft of runway surface, depending on the thickness of the rubber build-up.

Figure 4. The Folding Water Spray Bar in Use

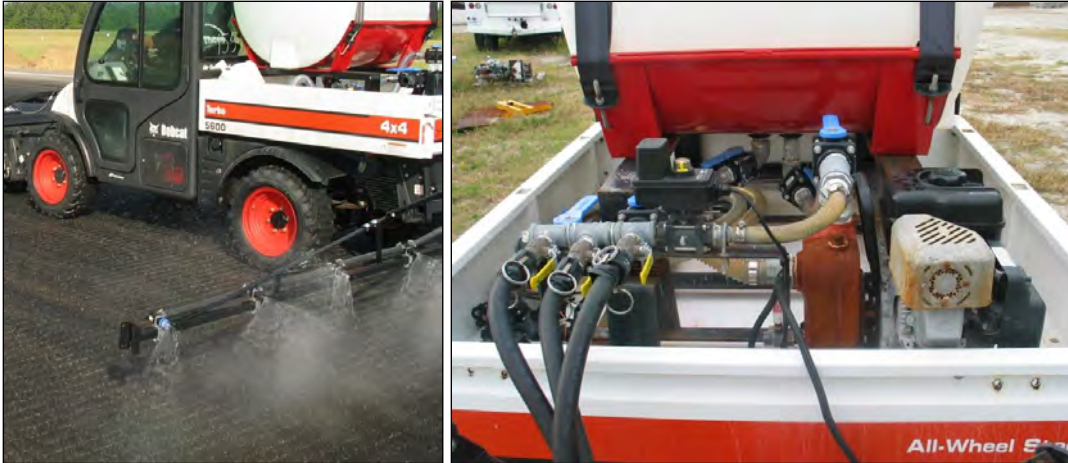
Figure 5. The Folding Spray Bar System Includes a Pump and Water Tank

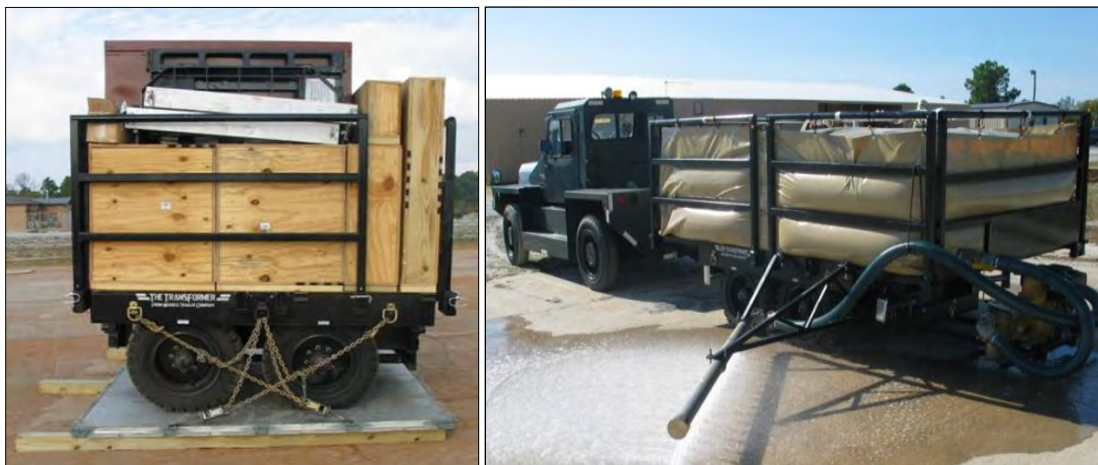
The water rinse down (transformer) trailer, shown in Figure 6, was custom designed to meet the 463L pallet requirements of a C-130 aircraft and provide a variety of options of transport and load configuration. During the rubber removal operation it contains a 2000-gal water bladder and water distribution system. The bladder can be filled in minutes from a fire hydrant and towed to the cleaning area. During transport it holds tool boxes, attachments, supplies and additional items.

Figure 6. The Foldable Water Rinse Down System

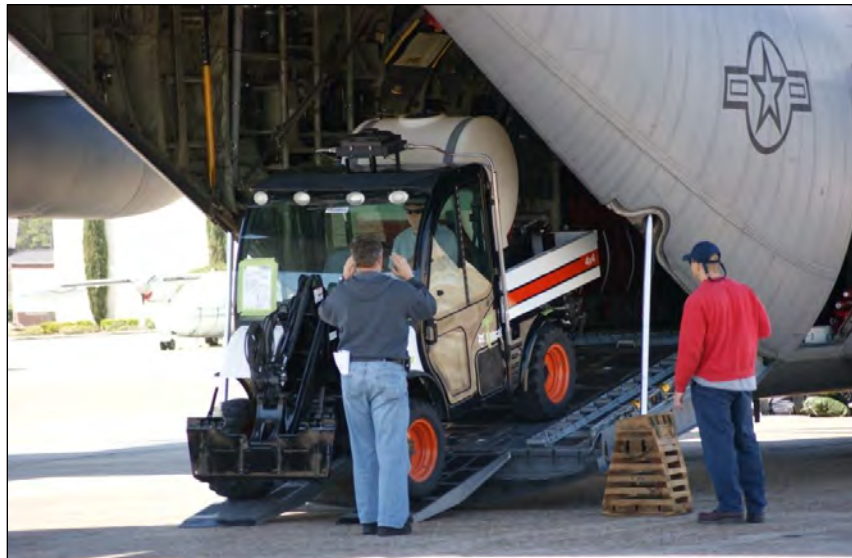
The deployment commenced 13 March 2010 after several attempts to arrange for an airlift aircraft. Figure 7 shows the Toolcat[®] being loaded into the C-17 aircraft. The Toolcat[®] was backed into the C-130 under self power without the need of any additional ramps or accessories.

Figure 7. Loading Equipment in the C-17 Aircraft

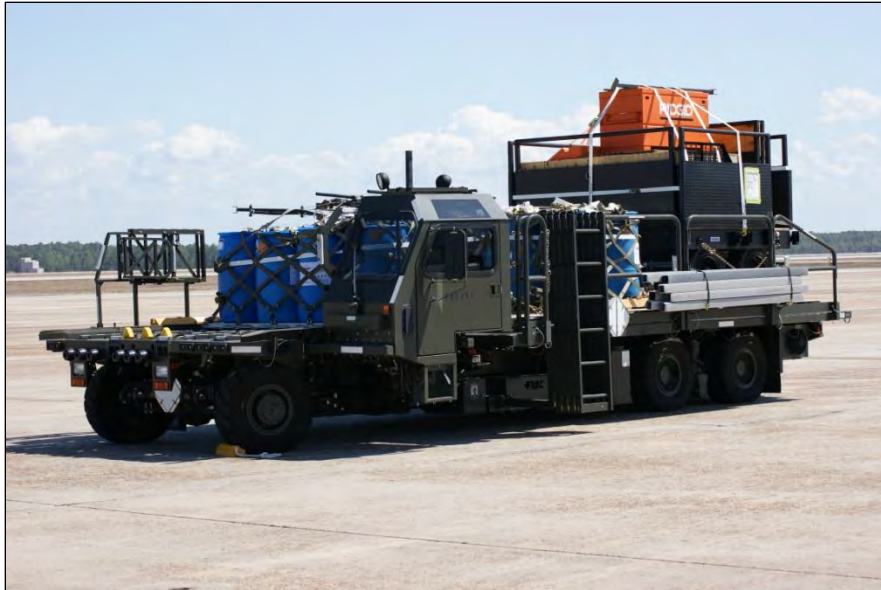
The detergent of choice was Avion50[®] based on past experience. Several detergents were previously investigated for other research efforts and Avion50[®] was selected for detailed evaluation during this deployment. The detergent pellets were loaded onto the K-Loader (25,000 lbs capacity) for loading onto the C-130 aircraft (Fig. 8).

Figure 8. Equipment and Detergent Pellets Were Loaded Using the K-loader

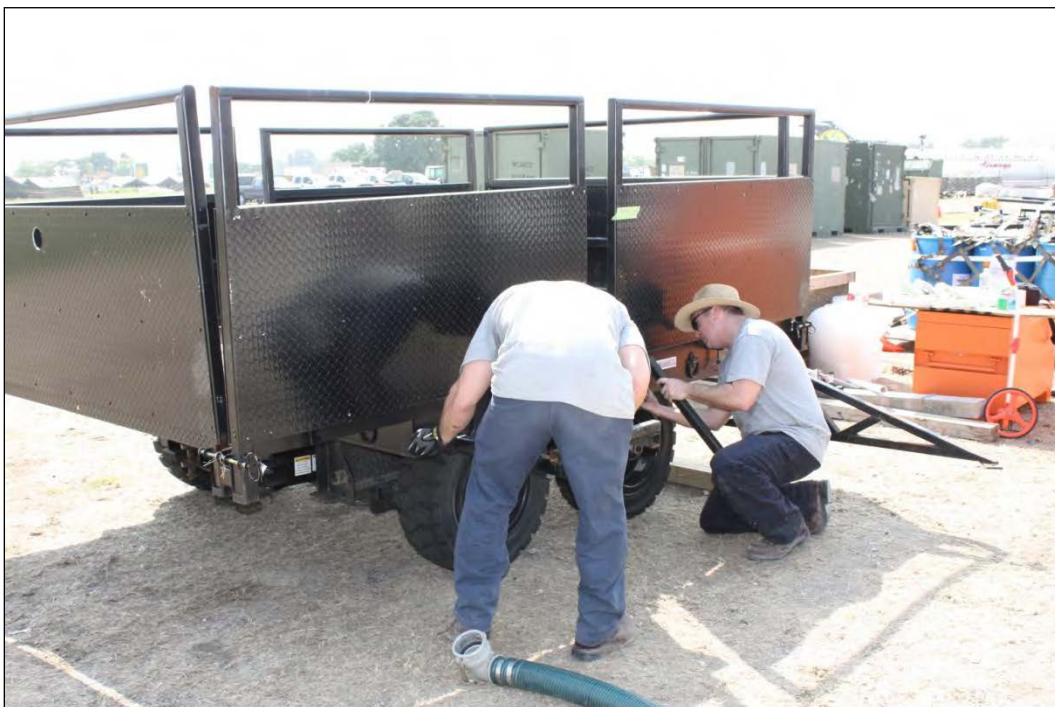
Figure 10. Transformer Trailer Being Set up in Preparation for Work

- Unstrapped the transformer trailer from the 463L pallet and removed the trailer with a 10K all-terrain fork lift.
- Removed the side rails from the transformer trailer to use the Toolcat[®] with the forks attachment to unload all job boxes and crates from the trailer.
- With the trailer unloaded, the next step deployed the trailer to its full operating setup (Figure 10).
- Once the trailer was set up, the liner and the water bladder were installed (Figure 11).
- After the bladder was installed, the water pump and the spray bar were attached and all plumbing was connected. At this point the trailer was ready to be filled with water and put to use.
- The Toolcat[®] was set up next by installing the spray bar on the back of the Toolcat[®] (Figure 12), hanging the magnet and changing the forks attachment to the broom attachment.

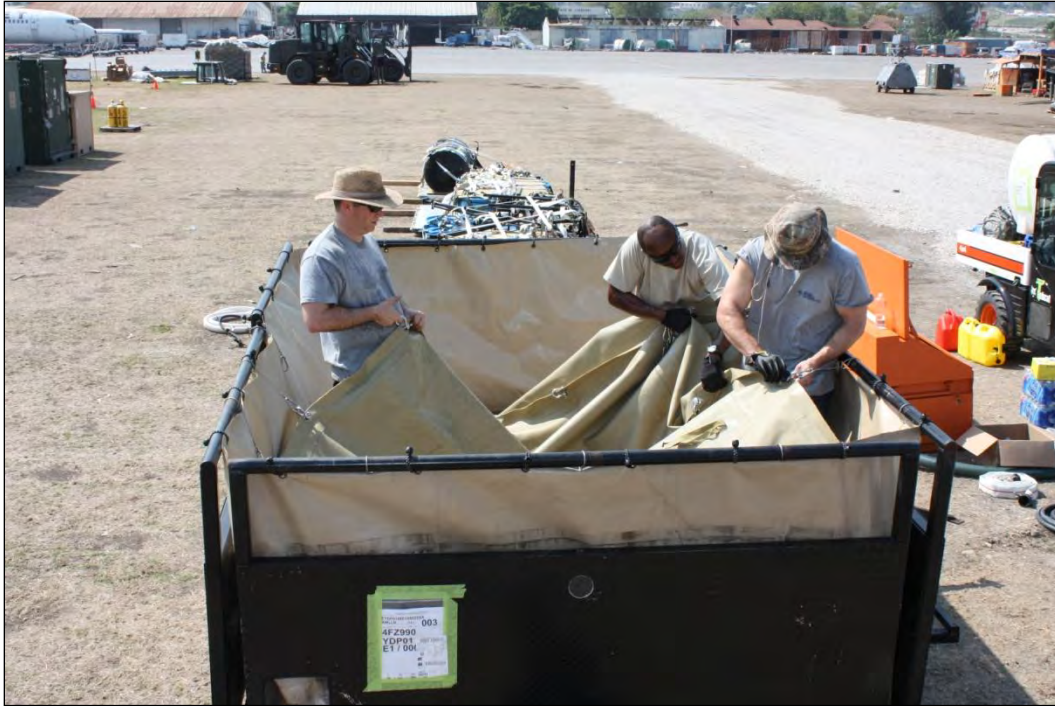
Figure 11. Water Bladder is Unfolded and Anchored in the Trailer to Carry Water

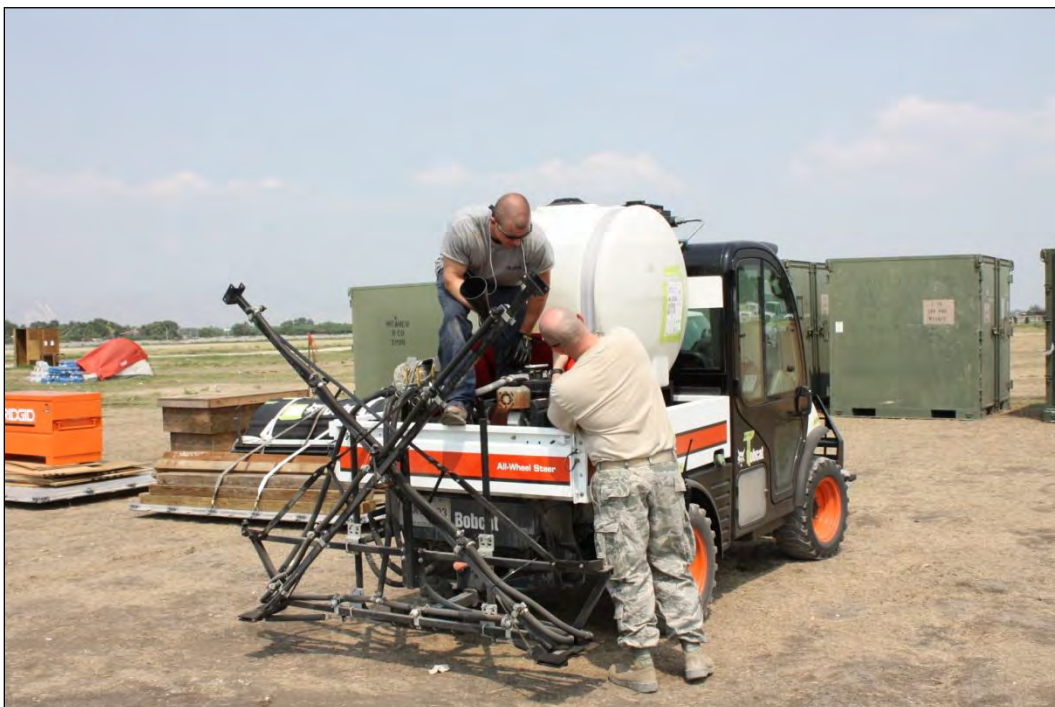
Figure 12. The Toolcat[®] Spray Bar Attachment Being Connected

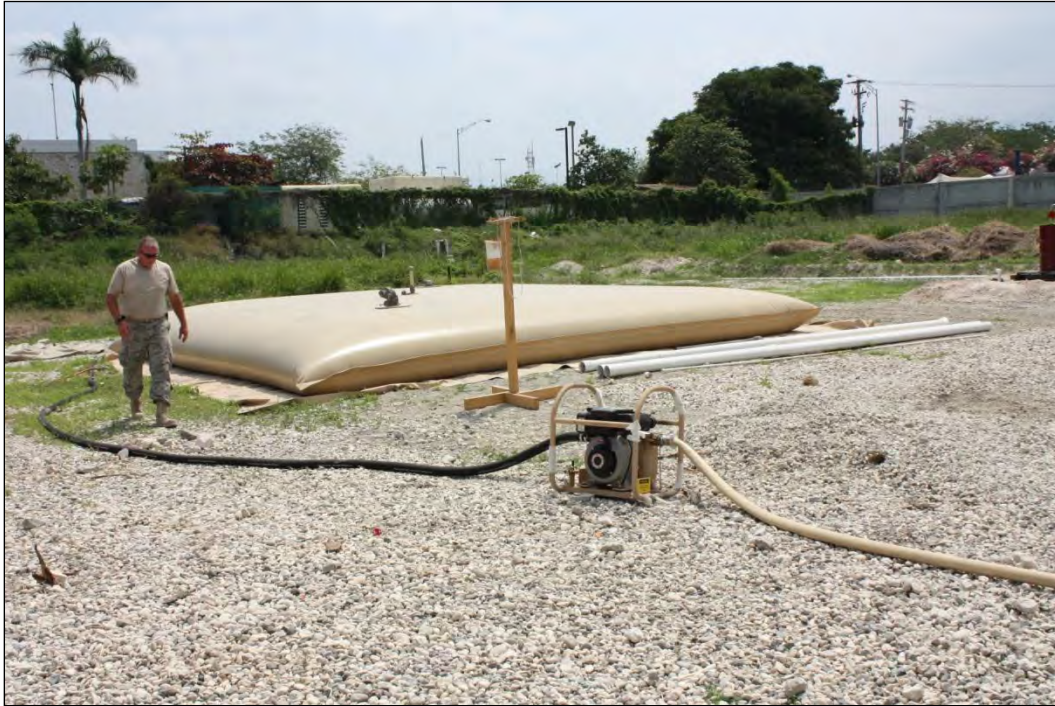
Toolcat[®] pump, the pump on the transformer trailer, the Toolcat[®] and the reserve gas cans were filled with fuel. The water bladder on the transformer trailer (Fig. 13) was filled about 30 min prior to starting work on the runway for the first night.

Figure 13. Water Being Transferred to Toolcat[®] and Transformer Trailer

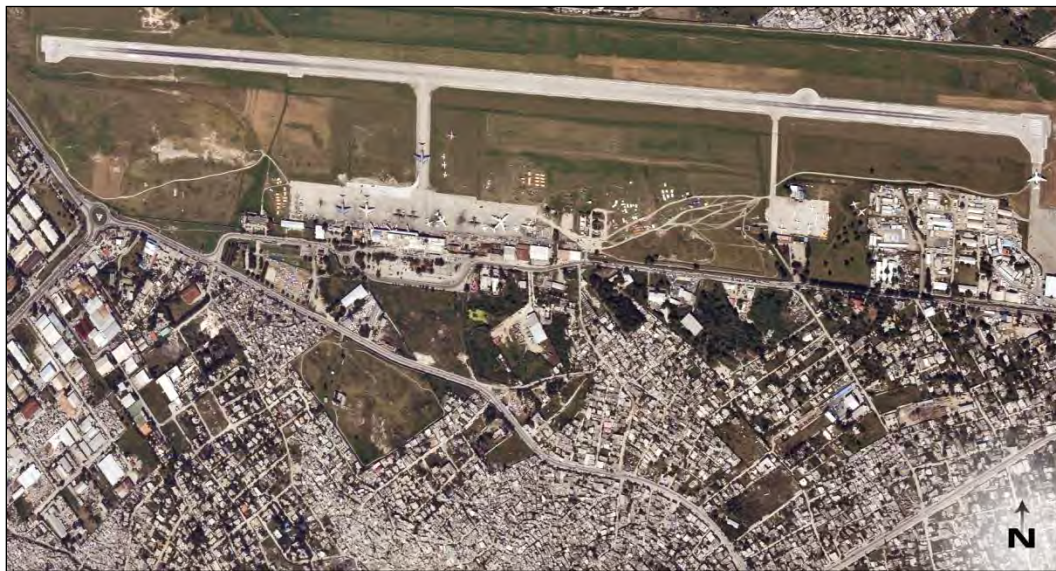
After an initial survey of the condition of the runway, a plan for the operations was established and work began to stage the equipment and rubber removal detergents. In the weeks leading up to the deployment by AFRL the Airfield Pavements Evaluation Team (APE) from AFCESA had conducted a full evaluation of PAP Runway 10-28 and reported that the rubber build-up was medium to heavy over the touchdown and deceleration areas. This accumulation is visible in the image of the layout and Runway 10-28 at PAP shown in Figure 14.

Figure 14. Layout of Runway 10-28 and Apron at PAP

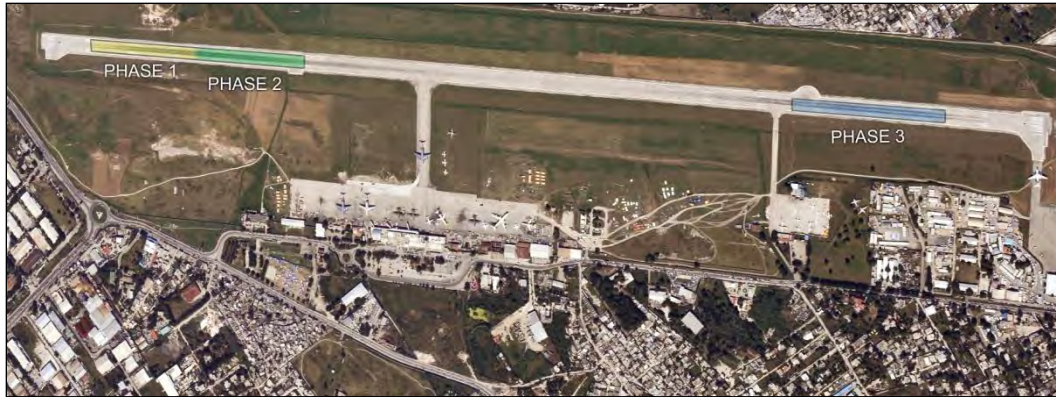
The rubber removal operation was divided into three phases shown in Figure 15. Table 1 shows calculated application rates of both detergent and rinse water.

Figure 15. Phases for Evaluation of the Detergent Rubber Removal System

The area to be cleaned on the 10-end of Runway 10-28 exceeds the cleaning capability of the equipment for a single 8-hour application; therefore, the 125,000 sq ft area was cleaned in two 8-hour shifts. Per manufacturer's recommendation the application rates are 55 gal of detergent and 3,000 gal of rinse water per 10,000 sq ft.

System evaluation on the first night (15 March 2010) consisted of cleaning 62,500 sq ft on the 10-end of Runway 10-28. The area cleaned was 1,250 ft x 50 ft beginning 500 ft from the 10-end threshold and extending to 1,750 ft from the 10-end of Runway 10-28 threshold (Figure 15).

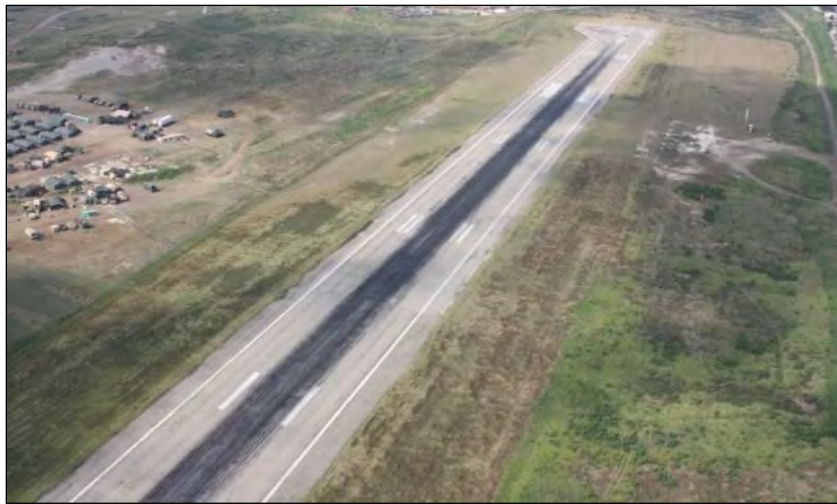
local. Figure 16 shows the condition of the 10-end of Runway 10-28 before removal of accumulated rubber. Figure 17 shows the condition of the 10-end Runway 10-28 after rubber removal.

Figure 16. 10-end of Runway 10-28 Before Rubber Removal

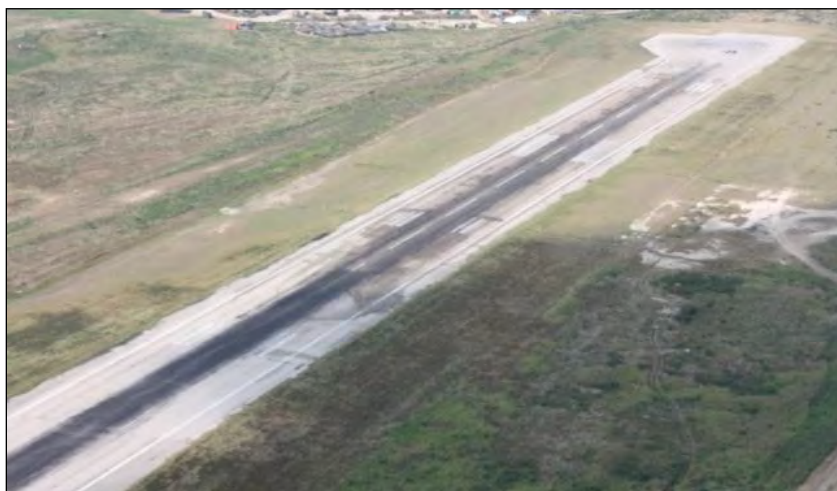
Figure 17. 10-end of Runway 10-28 After Phase I Rubber Removal

The rinse process called for 19,500 gal of rinse water; however, due to difficulties obtaining these large quantities of water in a timely manner, only 11,000 gal of water were used. The result of using less water is that the runway has a brown stained appearance. This brown staining is typical when cleaning with detergents; however the staining was slightly heavier due to the limited amount of rinse water used in the process. The brown staining usually will rinse away in a short time after a few rainfalls. However, the results of the cleaning were as good as or better than expected. Overall the process went well the first night with the exception of the shortage of available rinse water.

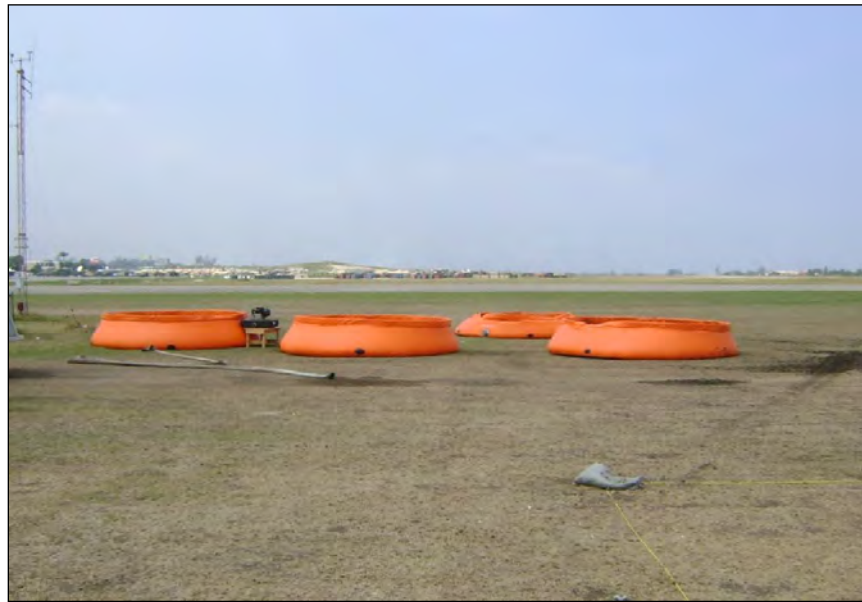
The Haitian contractor responsible for providing the requisite rinse water was not informed of the overnight operation and provided only a portion of the required water needed for rinsing (thus the staining shown in Figure 17). Alternate arrangements were made with the Fire Department to provide the additional water with one of their 5000-gal water tanker trucks for rinsing. It was decided that the team would borrow four 2,500-gal capacity onion bladders from the Fire Department to stockpile water for the second night of cleaning. During daylight hours the onion bladders were filled with water as shown in Figure 18.

Figure 18. Four 2500-gal Capacity Onion Bladders Stored Water for Later Use

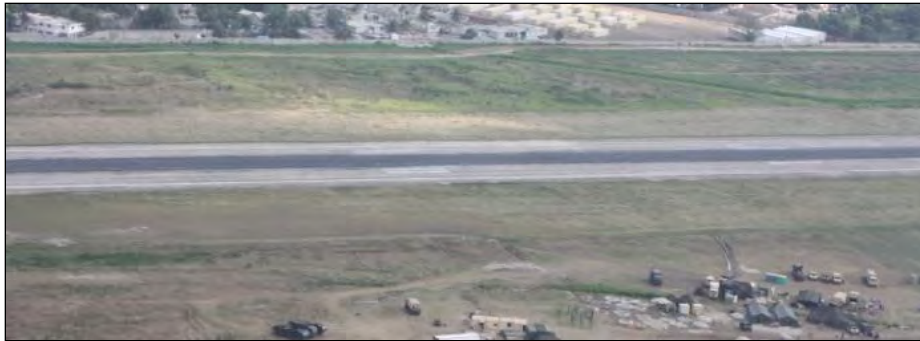
however, only 12,000 gal of water were used. By utilizing the water banking system with the four 2,500-gal-capacity onion bladders delivery of water was to the runway much more consistent (i.e., very little downtime awaiting water delivery, which allows the detergent to dry). The results of this seamless water delivery along with good conditions allowed less water to be used than recommended to achieve the desired results. Although the cleaning process exceeded expectations the area will continue to lighten up with rainfall events. Figure 19 and Figure 20 compare the condition of Runway 10-28 before and after removal of the accumulated rubber.

Figure 19. 10-end of Runway 10-28 Before Rubber Removal

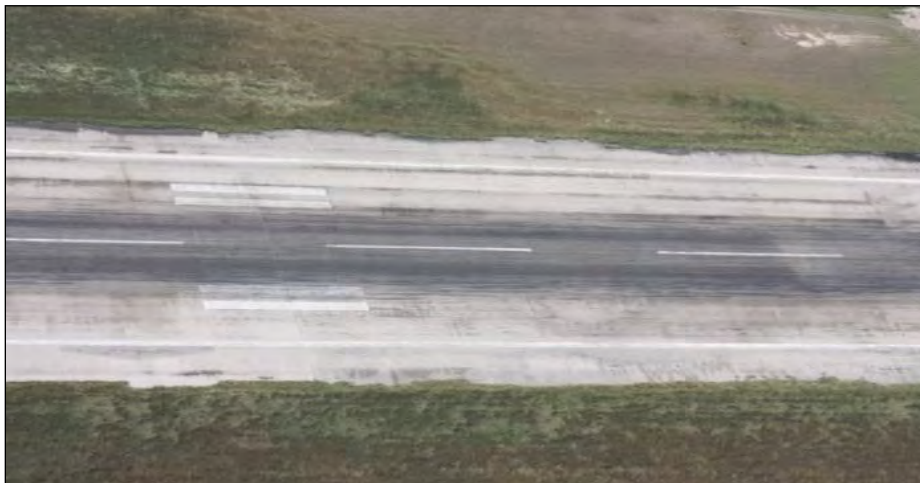
Figure 20. 10-end of Runway 10-28 After Phase II Rubber Removal

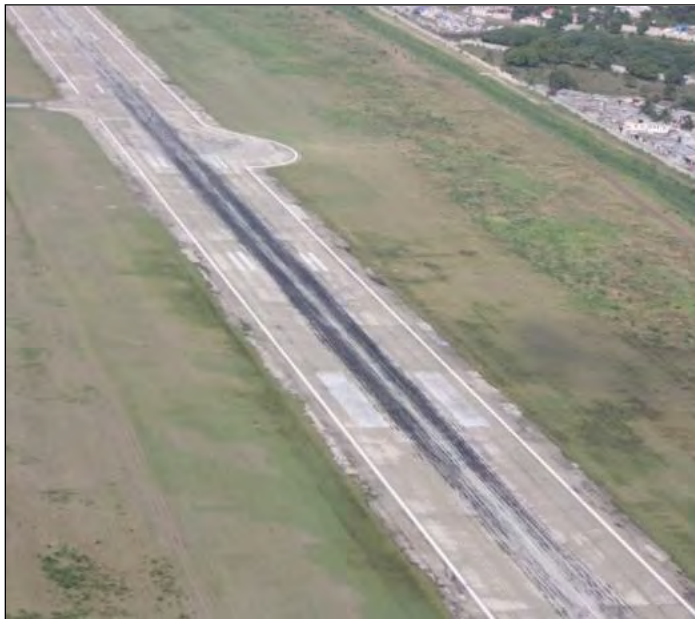
A total of 385 gal of detergent were applied to the test section. Before agitation began, the detergent was allowed 30 min to soak. The rinse cycle began at 0200 and ended at 0500. The rinse process called for 21,000 gal of rinse water; however, only 15,000 gal of water were used. Once again by utilizing the water banking system with the 2,500-gal capacity onion bladders water was delivered to the runway much more consistently. The results of this seamless water delivery along with good conditions allowed the team to use less water than recommended and achieve the desired results. Figures 21 and 22 compare the condition of Runway 10-28 before and after rubber removal.

Figure 21. Eastern End of Runway 10-28 Before Phase III Rubber Removal

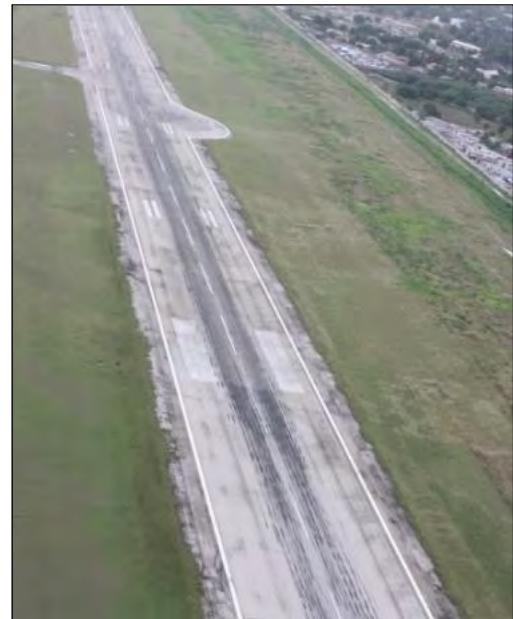
Figure 22. Easter End of Runway 10-28 After Phase III Rubber Removal
